**Flood Control Project Maintenance  
Levee Inspections**

**Fall 2019 Levee Maintenance Deficiency Summary Report**

<b>RD0349</b>	Overall LMA Rating	Total LMA Miles						
<b>Reclamation District No. 0349 Sutter Island</b>	<b>U</b>	<b>12.41</b>						
Rated Item	Maintenance Deficiency				Enforcement		Design & System Obsolescence	
	M Miles	U Miles	M + 4U Miles	Threshold %	M Miles	U Miles	M Miles	U Miles
<i>Earthen Levee</i>								
Vegetation	5.48	3.84	20.84	167.97%	0.14	0.57		
Trim / Thin Trees	0.26	0.04	0.42	3.39%				
Encroachments	0.24		0.24	1.93%	1.04	0.29		
Animal Control	0.18		0.18	1.45%				
Slope Stability	0.01		0.01	0.08%				
Crown Surface / Depressions / Rutting	0.01		0.01	0.08%				
Flood Preparedness & Training	0.12		0.12	0.97%				
<i>Supplemental</i>								
2017 USACE Erosion Survey	0.35		0.35	2.82%				
DRAFT DWR UCIP Field Study					0.50	0.01		
2017 Storm Damage	0.22		0.22	1.77%				
<i>LMA Totals:</i>	6.87	3.88	22.39	180.46%	1.68	0.87	0.00	0.00

**Flood Control Project Maintenance  
Levee Inspections****LMA District Cover Sheet  
Fall 2019 Levee Inspection Results****Reclamation District No. 0349 Sutter Island**

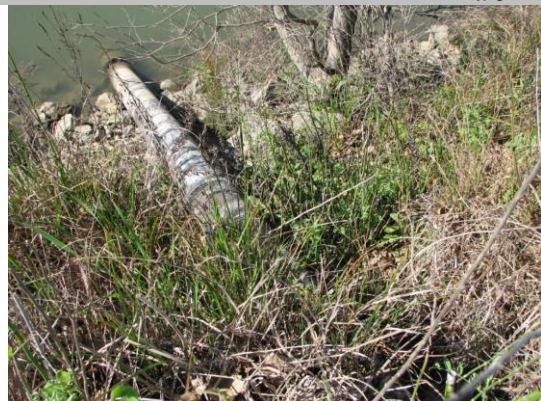
Photo 2 of 3 : UCIP\_FA\_2019\_43431\_36801.jpg

Pipe located on waterward side.

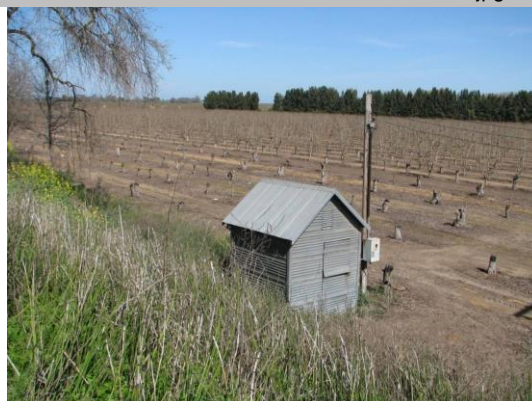
Photo 3 of 3 : UCIP\_FA\_2019\_43431\_36798.jpg

Comment Code						
Inspector Comment						
DS_ID:24186 FS_ID:43431 EP_NO: 15359 Repair Type: Non-Urgent Crossing Status: Found UCIP Comments: Dense vegetation limits the inspector's visibility to identify signs of pipe failure (leaks) through the levee slopes. Recommend removing vegetation along pipe alignment to conduct proper inspection of structure and appurtenances. Note date on photos should be 3/18/09 not 7/26/08 camera metadata is incorrect. FIELD_STRUCT_DESC: 10-inch steel irrigation pipe sleeved through a 12-inch conductor pipe through the levee, 6.0 feet below the levee crown. Siphon breaker in protective house at levee shoulder. Pump in pump house and power pole at landside (LS) toe. Pipe connected to 8-inch exposed pipe at LS shoulder, extending to pump house. Filter screen in channel at waterside (WS) toe. (existing 4-inch pipe removed and new 10-inch sleeved through 12-inch installed under Permit No. 15359, 1990 - E. Delta Orchards) [Additional Reference(s): DWR Levee Log, 2005] FS Date: 3/19/2009

View of landward side.

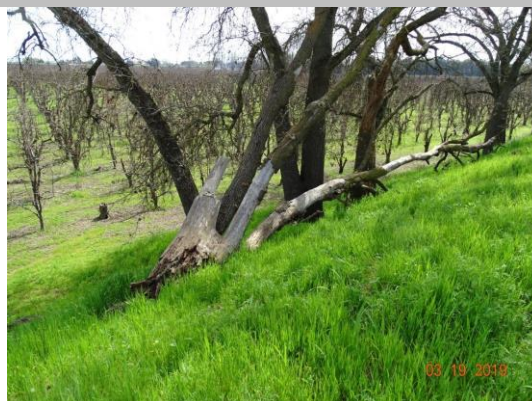
Photo 1 of 1 : FA\_2019\_RD0349\_206\_61\_20190826\_00014.jpg

LM Start	5.10	Rating **	M	Issue No.	61
LM End	5.22	Issue Type +	Ma	Location *	LS
Category	Earthen Levee			GPS Latitude/Longitude	
				Start	End
Item	Encroachments			38.321130 °	38.322715 °
				-121.589678 °	-121.589395 °
DWR ID	DWR_RD0349_03_s_2019_61				
Comment Code					
TR : Tree or limb					
Inspector Comment					
Remove fallen tree from the landside slope.

View looking downstream at down tree on the landside slope (Spring 2019).

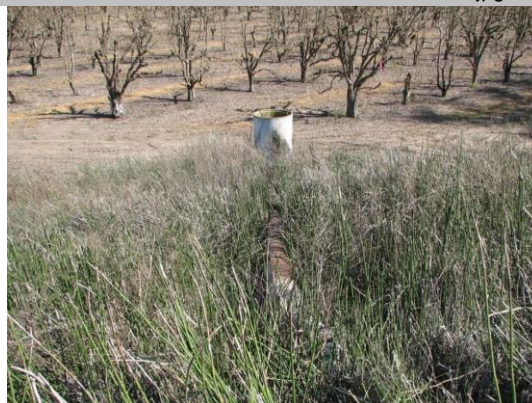
Photo 1 of 2 : UCIP\_FA\_2019\_43433\_70484.jpg

Comment Code					
Inspector Comment					
DS_ID:24188 FS_ID:43433 EP_NO: N/A Repair Type: Non-Urgent Crossing Status: Found UCIP Comments: Walkway is no longer functional. Need to contact owner--if crossing is no longer used owner will need to coordinate with DWR Inspector and CVFPB. Dense vegetation limits the inspector's visibility to identify signs of pipe failure (leaks) through the levee slopes. Recommend removing vegetation along pipe alignment to conduct proper inspection of structure and appurtenances. Note date on photos should be 3/18/09 not 7/26/08 camera metadata is incorrect. FIELD_STRUCT_DESC: 12-inch irrigation pipe of unknown material through the levee, 6.2 feet below the crown. Pump and control panel on piling structure in stream, with walkway. Service pole and concrete standpipe on the landside (LS) slope. [Additional Reference(s): DWR Levee Log, 2005. USACE Sacramento O&M Manual Unit No. 110, May 1959, revised 29 Dec 2016, (HLM 5.5)] FS Date: 3/19/2009

View of landward side--pipe and stand pipe visible.

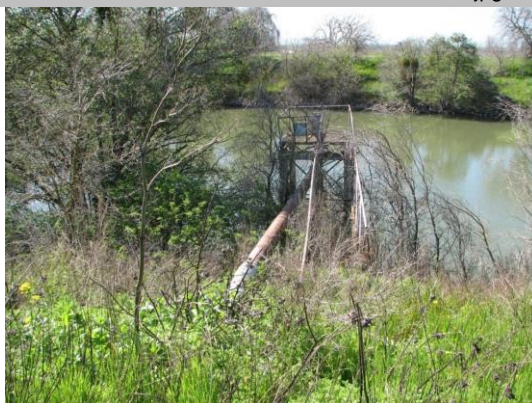
Photo 2 of 2 : UCIP\_FA\_2019\_43433\_70483.jpg

Comment Code						
Inspector Comment						
DS_ID:24188						
FS_ID:43433						
EP_NO: N/A						
Repair Type: Non-Urgent						
Crossing Status: Found						
UCIP Comments: Walkway is no longer functional. Need to contact owner--if crossing is no longer used owner will need to coordinate with DWR Inspector and CVFPB. Dense vegetation limits the inspector's visibility to identify signs of pipe failure (leaks) through the levee slopes. Recommend removing vegetation along pipe alignment to conduct proper inspection of structure and appurtenances. Note date on photos should be 3/18/09 not 7/26/08 camera metadata is incorrect.						
FIELD_STRUCT_DESC: 12-inch irrigation pipe of unknown material through the levee, 6.2 feet below the crown. Pump and control panel on piling structure in stream, with walkway. Service pole and concrete standpipe on the landside (LS) slope. [Additional Reference(s): DWR Levee Log, 2005. USACE Sacramento O&M Manual Unit No. 110, May 1959, revised 29 Dec 2016, (HLM 5.5)]

View of waterward side--pipe and remaining appurtenances.

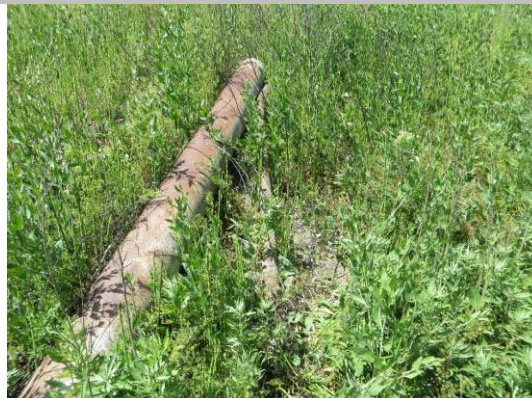
Photo 1 of 3 : UCIP\_FA\_2019\_44391\_73749.jpg

LM Start	5.19	Rating **	M	Issue No.	140
LM End	5.19	Issue Type +	En	Location *	
Category	Supplemental			GPS Latitude/Longitude	
				Start	End
Item	DRAFT DWR UCIP Field Study			38.322460 °	38.322460 °
				-121.589690 °	-121.589690 °
DWR ID	24189				
Comment Code					
Inspector Comment					
DS_ID:24189 FS_ID:44391 EP_NO: N/A Repair Type: Non-Urgent Crossing Status: Found UCIP Comments: Appears abandoned and if so should be done so properly. FIELD_STRUCT_DESC: 4-inch irrigation pipe of unknown material through the levee, 3.3 feet below the crown. Gate and pump on platform at the landside (LS) toe (missing). Platform on the waterside (WS). [Additional Reference(s): DWR Levee Log, 2005. USACE Sacramento O&M Manual Unit No. 110, May 1959, revised 29 Dec 2016, (HLM 5.6)] FS Date: 4/9/2015

4-inch pipe next to larger pipe on LS slope.

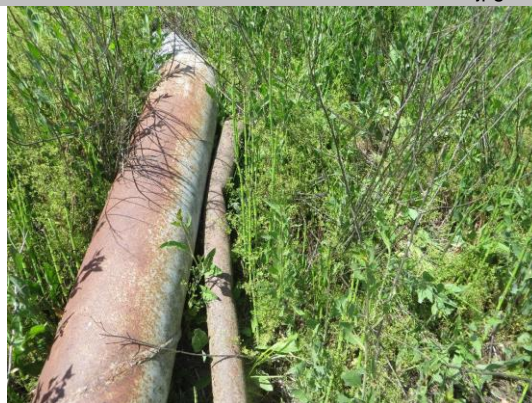
Photo 2 of 3 : UCIP\_FA\_2019\_44391\_73748.jpg

4-inch pipe next to larger pipe on LS slope.

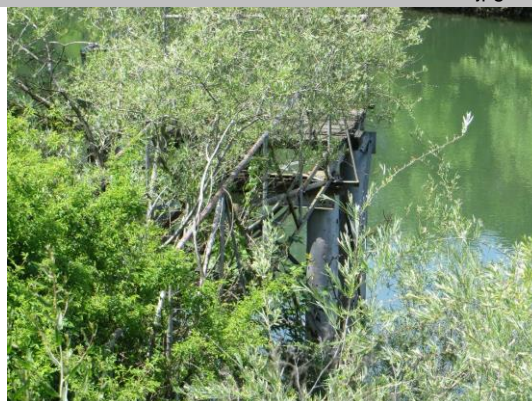
Photo 3 of 3 : UCIP\_FA\_2019\_44391\_73747.jpg

LM Start	5.19	Rating **	M	Issue No.	140 (cont)	
LM End	5.19	Issue Type +	En	Location *		
Category	Supplemental			GPS Latitude/Longitude		
				Start	End	
Item	DRAFT DWR UCIP Field Study			38.322460 °	38.322460 °	
				-121.589690 °	-121.589690 °	
DWR ID	24189					
Comment Code						
Inspector Comment						
DS_ID:24189 FS_ID:44391 EP_NO: N/A Repair Type: Non-Urgent Crossing Status: Found UCIP Comments: Appears abandoned and if so should be done so properly. FIELD_STRUCT_DESC: 4-inch irrigation pipe of unknown material through the levee, 3.3 feet below the crown. Gate and pump on platform at the landside (LS) toe (missing). Platform on the waterside (WS). [Additional Reference(s): DWR Levee Log, 2005. USACE Sacramento O&M Manual Unit No. 110, May 1959, revised 29 Dec 2016, (HLM 5.6)] FS Date: 4/9/2015

Pier on WS toe.

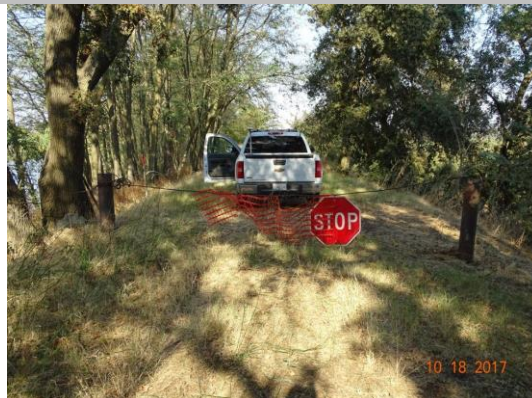
Photo 1 of 1 : FA\_2019\_RD0349\_206\_21\_20190826\_00002.jpg

LM Start	5.39	Rating **	U	Issue No.	21
LM End	5.39	Issue Type +	En	Location *	CR
Category	Earthen Levee			GPS Latitude/Longitude	
				Start	End
Item	Encroachments			38.323659 °	38.323659 °
				-121.586421 °	-121.586421 °
DWR ID	DWR_RD0349_03_f_2017_21				
Comment Code					
FE : Fence					
Inspector Comment					
Cable gates are not allowed and must be removed.

Cable gates are banned. Must remove. No lock on this gate.

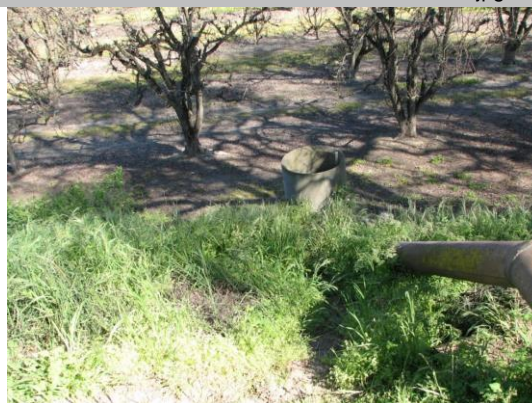
Photo 1 of 3 : UCIP\_FA\_2019\_50016\_36841.jpg

UCIP Comments: 8/22/2016 Crossing has been downgraded from Urgent to Non-Urgent no signs of pipe failure were present on levee crown or slopes during site visit. Need to contact owner to determine last internal inspection completed. (DWR UCIP - omagana)3/19/2009 Soil disturbed on landward slope--need to contact owner. Also vegetation limits the inspector's visibility to identify signs of pipe failure (leaks) along the slope. Recommend removing vegetation along pipe alignment to conduct proper inspection of structure and appurtenances. Note date on photos should be 3/18/09 not 7/26/08 camera metadata is incorrect. (DWR UCIP - omagana)

FIELD\_STRUCT\_DESC: 10-inch irrigation pipe of unknown material through the levee, 3.8 feet below the crown. Pump in pump house on waterside (WS). Service pole on WS slope. Concrete standpipe and distribution box located on the WS toe. Pipe is exposed on both slopes. Section of pipe under crown, between shoulders, removed and replaced with 10-inch steel pipe in November 20, 1991, no permit application was filed. In August 13, 1993, Mr. Steve Makis of Flood Management, revealed that the pipe was not soil proofed, and siphon breaker was not installed, and backfill was less than 90 % and less than 2-foot of cover through the levee crown. Pipe was required to be completely removed and replaced in September 15, 1993. (10-inch authorized under Permit No. 16077, 1993 - John McCormack Company, 10-inch pipe replaces the USACE O&M 10-inch pipe referenced as HLM 5.9) [Additional Reference(s): DWR Levee Log, 2005. USACE San Joaquin O&M Manual Unit No. 110, May 1959, HLM 5.9, Drawing not available]. FS Date: 8/17/2016

View of LS--pipe and stand pipe visible.

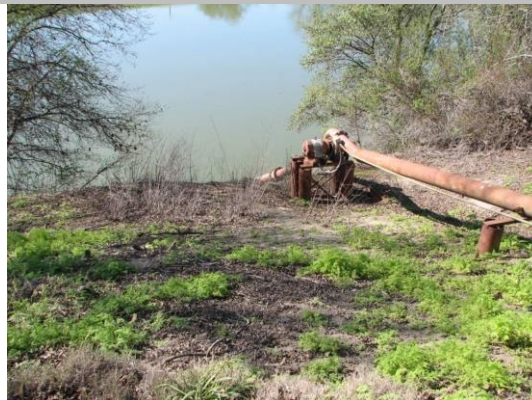
Photo 2 of 3 : UCIP\_FA\_2019\_50016\_36843.jpg

Comment Code						
Inspector Comment						
DS_ID:24190 FS_ID:50016 EP_NO: 16077 Repair Type: Non-Urgent Crossing Status: Found UCIP Comments: 8/22/2016 Crossing has been downgraded from Urgent to Non-Urgent no signs of pipe failure were present on levee crown or slopes during site visit. Need to contact owner to determine last internal inspection completed. (DWR UCIP - omagana)3/19/2009 Soil disturbed on landward slope--need to contact owner. Also vegetation limits the inspector's visibility to identify signs of pipe failure (leaks) along the slope. Recommend removing vegetation along pipe alignment to conduct proper inspection of structure and appurtenances. Note date on photos should be 3/18/09 not 7/26/08 camera metadata is incorrect. (DWR UCIP - omagana) FIELD_STRUCT_DESC: 10-inch irrigation pipe of unknown material through the levee, 3.8 feet below the crown. Pump in pump house on waterside (WS). Service pole on WS slope. Concrete standpipe and distribution box located on the WS toe. Pipe is exposed on both slopes. Section of pipe under crown, between shoulders, removed and replaced with 10-inch steel pipe in November 20, 1991, no permit application was filed. In August 13, 1993, Mr. Steve Makis of Flood Management, revealed that the pipe was not soil proofed, and siphon breaker was not installed, and backfill was less than 90 % and less than 2-foot of cover through the levee crown. Pipe was required to be completely removed and replaced in September 15, 1993. (10-inch authorized under Permit No. 16077, 1993 - John McCormack Company, 10-inch pipe replaces the USACE O&M 10-inch pipe referenced as HLM 5.9) [Additional Reference(s): DWR Levee Log, 2005. USACE San Joaquin O&M Manual Unit No. 110, May 1959, HLM 5.9, Drawing not available]. FS Date: 8/17/2016

View of pipe and pump along WS slope.

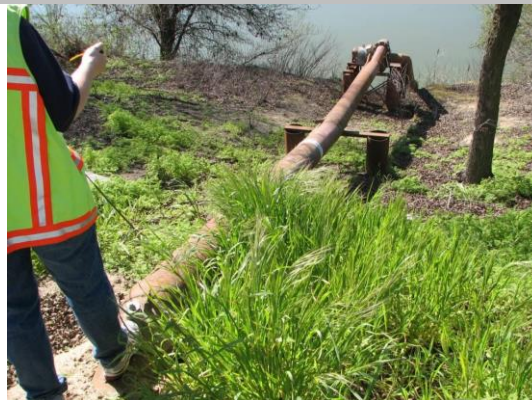
Photo 3 of 3 : UCIP\_FA\_2019\_50016\_36842.jpg

Comment Code						
Inspector Comment						
DS_ID:24190 FS_ID:50016 EP_NO: 16077 Repair Type: Non-Urgent Crossing Status: Found UCIP Comments: 8/22/2016 Crossing has been downgraded from Urgent to Non-Urgent no signs of pipe failure were present on levee crown or slopes during site visit. Need to contact owner to determine last internal inspection completed. (DWR UCIP - omagana)3/19/2009 Soil disturbed on landward slope--need to contact owner. Also vegetation limits the inspector's visibility to identify signs of pipe failure (leaks) along the slope. Recommend removing vegetation along pipe alignment to conduct proper inspection of structure and appurtenances. Note date on photos should be 3/18/09 not 7/26/08 camera metadata is incorrect. (DWR UCIP - omagana) FIELD_STRUCT_DESC: 10-inch irrigation pipe of unknown material through the levee, 3.8 feet below the crown. Pump in pump house on waterside (WS). Service pole on WS slope. Concrete standpipe and distribution box located on the WS toe. Pipe is exposed on both slopes. Section of pipe under crown, between shoulders, removed and replaced with 10-inch steel pipe in November 20, 1991, no permit application was filed. In August 13, 1993, Mr. Steve Makis of Flood Management, revealed that the pipe was not soil proofed, and siphon breaker was not installed, and backfill was less than 90 % and less than 2-foot of cover through the levee crown. Pipe was required to be completely removed and replaced in September 15, 1993. (10-inch authorized under Permit No. 16077, 1993 - John McCormack Company, 10-inch pipe replaces the USACE O&M 10-inch pipe referenced as HLM 5.9) [Additional Reference(s): DWR Levee Log, 2005. USACE San Joaquin O&M Manual Unit No. 110, May 1959, HLM 5.9, Drawing not available]. FS Date: 8/17/2016

View of WS.

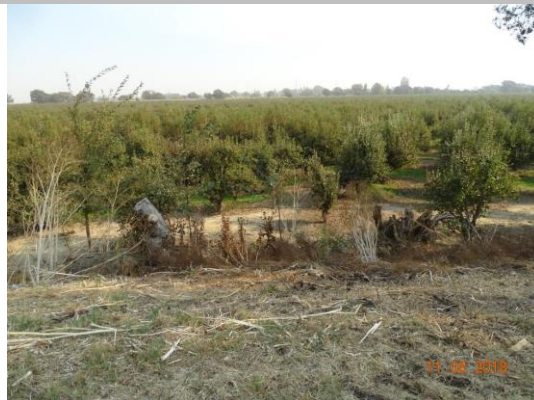
Photo 1 of 1 : FA\_2019\_RD0349\_206\_95\_20190826\_00021.jpg

LM Start	5.71	Rating **	M	Issue No.	95
LM End	5.71	Issue Type +	Ma	Location *	LS
Category	Earthen Levee			GPS Latitude/Longitude	
				Start	End
Item	Encroachments			38.327828 °	38.327828 °
				-121.584960 °	-121.584960 °
DWR ID	DWR_RD0349_03_f_2018_95				
Comment Code					
TR : Tree or limb					
Inspector Comment					
Remove down trees from the landside slope.

View of down trees on the landside slope (November 2018).

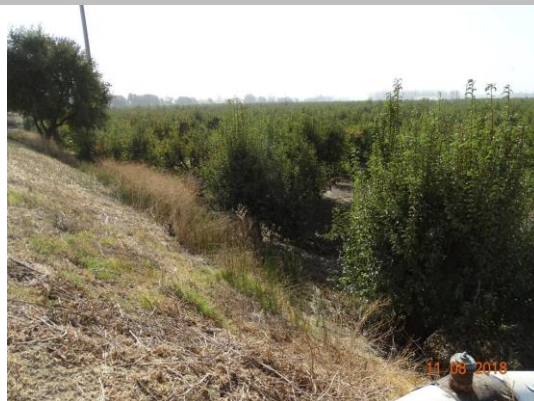
Photo 1 of 1 : FA\_2019\_RD0349\_206\_74\_20190826\_00018.jpg

LM Start	5.93	Rating **	M	Issue No.	74
LM End	6.32	Issue Type +	En	Location *	LS
Category	Earthen Levee			GPS Latitude/Longitude	
				Start	End
Item	Encroachments			38.330800 °	38.328882 °
				-121.584355 °	-121.579105 °
DWR ID	DWR_RD0349_03_f_2018_74				
Comment Code					
CR : Crops					
Inspector Comment					
Orchard trees are encroaching on the landside toe.

View looking slightly upstream at orchard trees on the landside toe (November 2018).

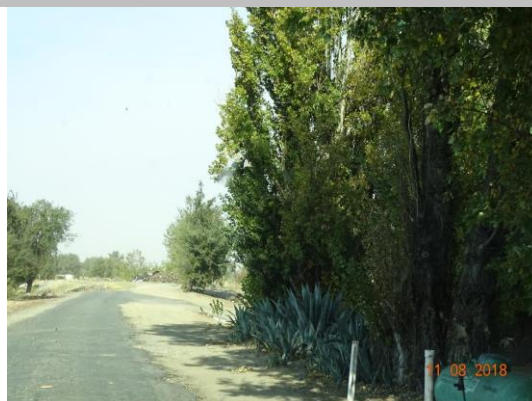
Photo 1 of 1 : FA\_2019\_RD0349\_206\_66\_20190826\_00016.jpg

LM Start	6.42	Rating **	U	Issue No.	66
LM End	6.42	Issue Type +	En	Location *	WS
Category	Earthen Levee			GPS Latitude/Longitude	
				Start	End
Item	Vegetation			38.327750°	38.327750°
				-121.577968°	-121.577968°
DWR ID	DWR_RD0349_03_f_2018_66				
Comment Code					
V6 : Landscaping					
Inspector Comment

View looking downstream at landscaping on the waterside shoulder (November 2018).

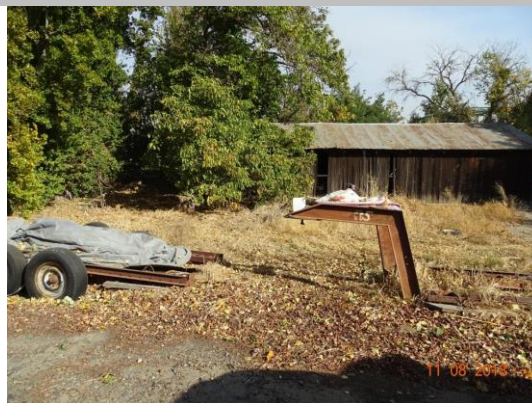
Photo 1 of 1 : FA\_2019\_RD0349\_206\_65\_20190826\_00015.jpg

LM Start	6.47	Rating **	M	Issue No.	65
LM End	6.47	Issue Type +	En	Location *	WS
Category	Earthen Levee			GPS Latitude/Longitude	
				Start	End
Item	Encroachments			38.327287 °	38.327287 °
				-121.577333 °	-121.577333 °
DWR ID	DWR_RD0349_03_f_2018_65				
Comment Code					
EQ : Equipment					
Inspector Comment					
Remove equipment from the waterside slope.

View of trailer and other equipment on the waterside shoulder (November 2018).
